**Flood Control Project Maintenance
Levee Inspections**

Fall 2011 Levee Maintenance Deficiency Summary Report

Sacramento River Basin

Sacramento Maintenance Yard Maintenance Area 0004

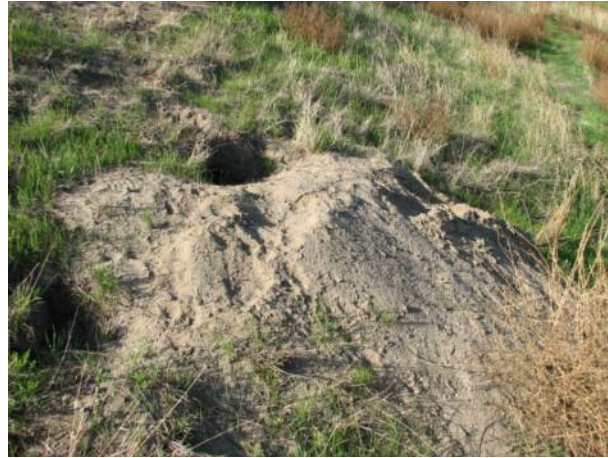
Levee Mile Report Line	1
Start Levee Mile	0.04
End Levee Mile	0.04
Location	Water Side
Category	Earthen Levee
Item	Animal Control

A large rodent hole Fall 2011

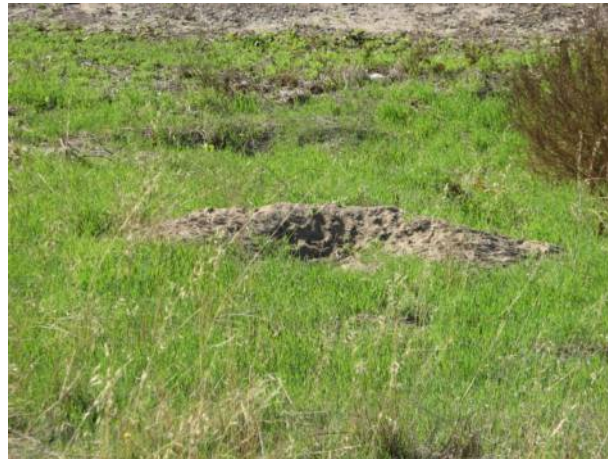
Levee Mile Report Line	2
Start Levee Mile	0.05
End Levee Mile	0.05
Location	Land Side
Category	Earthen Levee
Item	Animal Control

A large rodent hole. Fall 2011

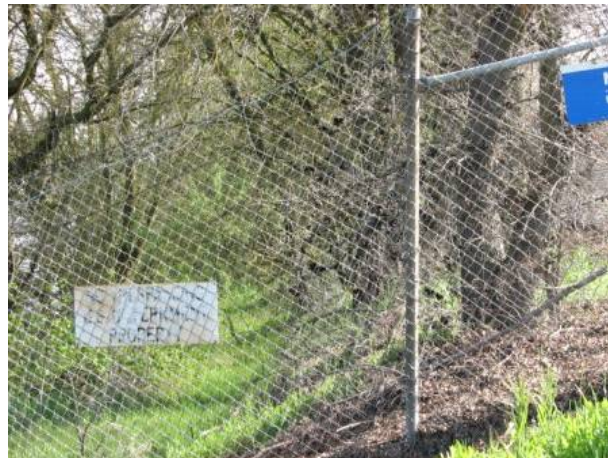
Levee Mile Report Line	4
Start Levee Mile	0.28
End Levee Mile	0.44
Location	Water Side
Category	Earthen Levee
Item	Trim / Thin Trees

The trees need to be trimmed up and thinned to meet standards.

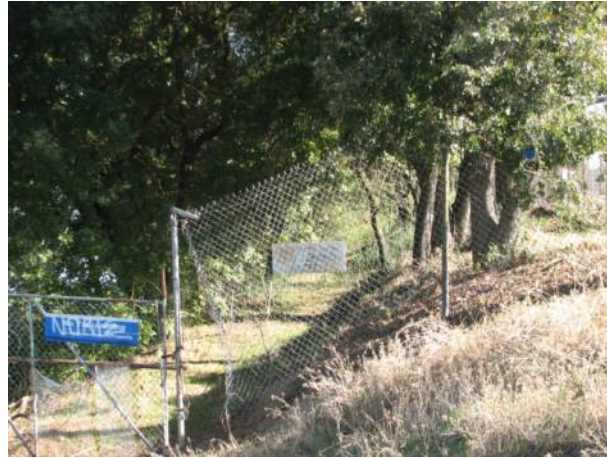
Levee Mile Report Line	4
Start Levee Mile	0.28
End Levee Mile	0.44
Location	Water Side
Category	Earthen Levee
Item	Trim / Thin Trees

The trees have been raised but vegetation needs to be trimmed. Fall 2011

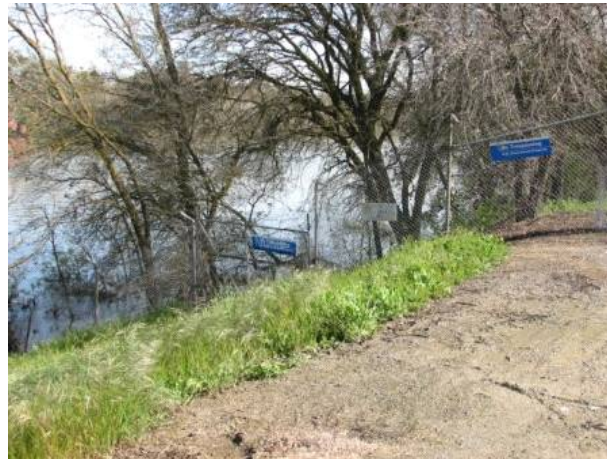
Levee Mile Report Line	5
Start Levee Mile	0.28
End Levee Mile	0.28
Location	Crown
Category	Earthen Levee
Item	Encroachments

The fence goes down the waterside with no removal sections.

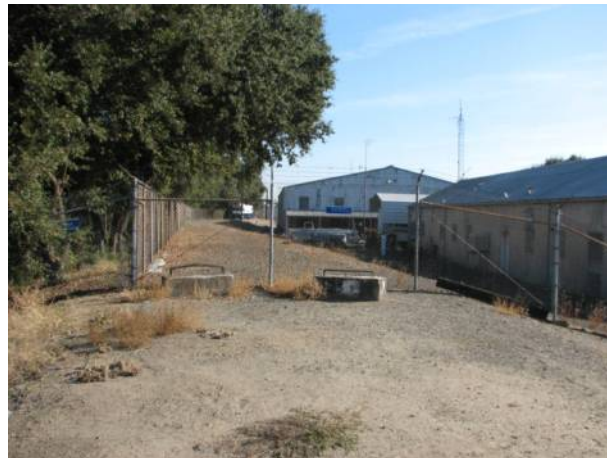
Levee Mile Report Line	5
Start Levee Mile	0.28
End Levee Mile	0.28
Location	Crown
Category	Earthen Levee
Item	Encroachments

5	0.28	0.28	Earthen Levee	Encroachments	CR	CO	Fences Inspector Comments: This is the USACE yard and the chain link fence crosses the levee. The fence runs the length of the yard on the crown.	38.597193 ° -121.543421 °	38.597193 ° -121.543421 °	2 Y
6	0.68	1.31	Earthen Levee	Crown Surface / Depressions / Rutting	CR	W	Regrade the crown roadway for proper drainage. Inspector Comments: I am unable to inspect this area due to construction. A SB wall and reconstruction of the levee is in progress.	38.600857 ° -121.537060 °	38.602755 ° -121.525830 °	177 Y
7	1.32	1.95	Earthen Levee	Encroachments	LS	PO	Landscaping Inspector Comments: The Rivers housing development	38.602756 ° -121.525618 °	38.600449 ° -121.514459 °	7 Y
8	1.33	1.49	Earthen Levee	Encroachments	CR	CO	Buildings Inspector Comments: The Rivers housing development houses on crown of levee waterside	38.602764 ° -121.525319 °	38.602596 ° -121.522439 °	8 Y

The fence crosses the levee crown with no gate for access. The buildings are the USACE yard. Fall 2011

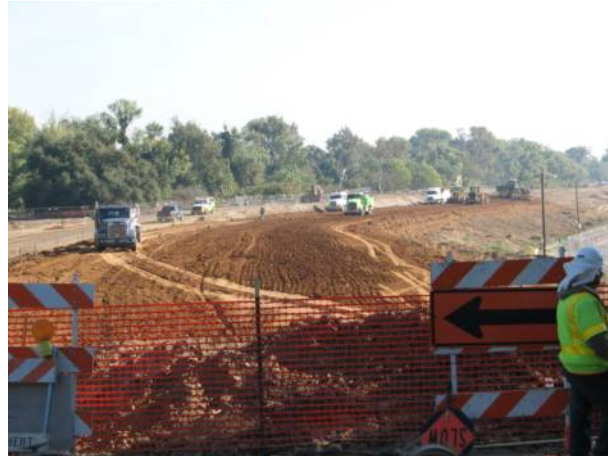
Levee Mile Report Line	6
Start Levee Mile	0.68
End Levee Mile	1.31
Location	Crown
Category	Earthen Levee
Item	Crown Surface / Depressions / Rutting
Reconstruction of the levee after the slurry wall has been completed. Fall 2011	
johngw_f_20111031_439.jpg

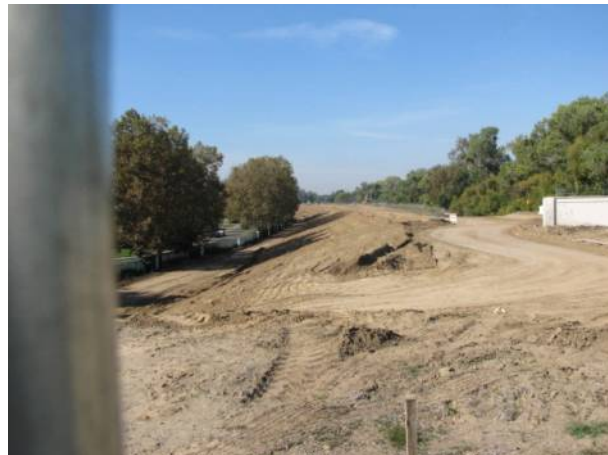
Levee Mile Report Line	6
Start Levee Mile	0.68
End Levee Mile	1.31
Location	Crown
Category	Earthen Levee
Item	Crown Surface / Depressions / Rutting
A view from the Rivers development. The groundcover has been removed and the levee was re-sloped. Fall 2011	
johngw_f_20111031_440.jpg

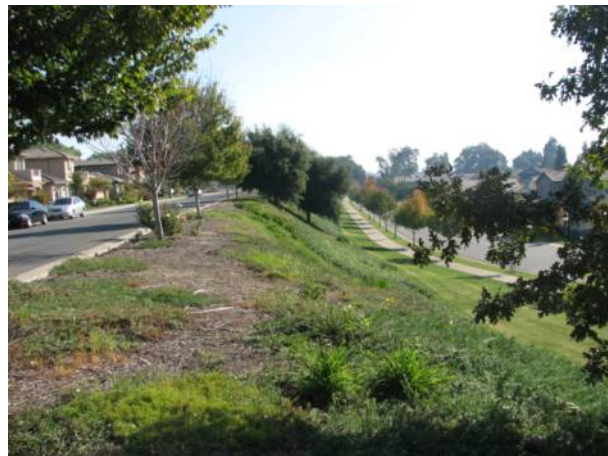
Levee Mile Report Line	7
Start Levee Mile	1.32
End Levee Mile	1.95
Location	Land Side
Category	Earthen Levee
Item	Encroachments
Landscaping on the landside slope outside of the Rivers development. Fall 2011	
johngw_f_20111031_441.jpg

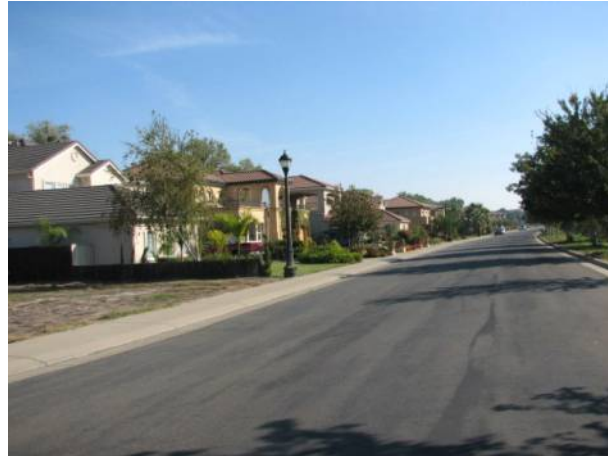
Levee Mile Report Line	8
Start Levee Mile	1.33
End Levee Mile	1.49
Location	Crown
Category	Earthen Levee
Item	Encroachments
Houses on the crown of the levee Fall 2011	
johngw_f_20111031_442.jpg

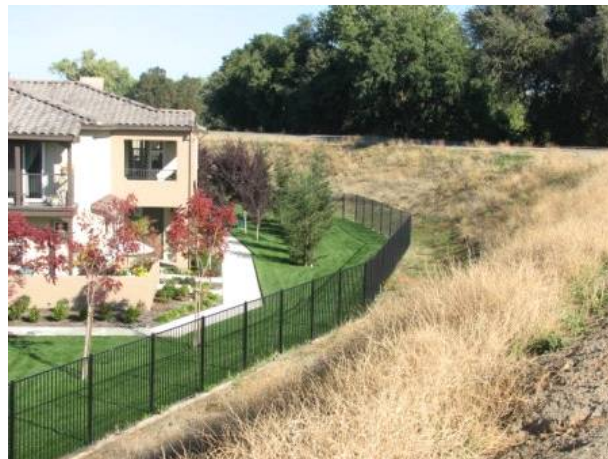
Levee Mile Report Line	9
Start Levee Mile	2.00
End Levee Mile	2.17
Location	Land Side
Category	Earthen Levee
Item	Encroachments
Fence and landscaping along the levee toe by the condos in the Rivers.	
johngw_f_20110923_010.jpg

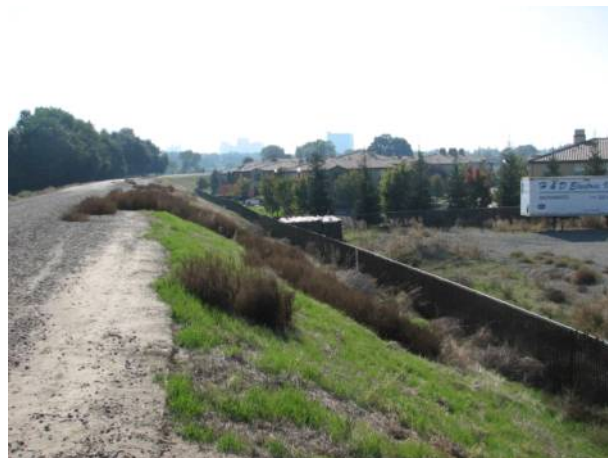
9	2.00	2.17	Earthen Levee	Encroachments	LS	CO	Fences Inspector Comments: A fence runs along the toe of the landside levee	38.599834 ° -121.513994 °	38.597531 ° -121.513147 °	14 Y
10	2.87	2.87	Earthen Levee	Vegetation	LS	M	Remove the wild growth other than native grasses from the levee slopes.	38.588989 ° -121.507952 °	38.588989 ° -121.507952 °	178 Y
11	3.02	3.02	Earthen Levee	Animal Control	WS	M	Exterminate rodents and backfill and compact or grout burrows.	38.586983 ° -121.508121 °	38.586983 ° -121.508121 °	179 Y
12	3.02	3.02	Earthen Levee	Encroachments	CR	CO	Fences Inspector Comments: Fence was installed from the 'I' St. bridge to 3rd St. on both sides of the railroad tracks. The fence crosses the crown. The crown was not accessible because of the railroad tracks before.	38.586887 ° -121.508150 °	38.586887 ° -121.508150 °	6 Y
13	3.07	3.30	Earthen Levee	Encroachments	LS	PO	Buildings Inspector Comments: CalSTRS building and Ziegot building	38.585640 ° -121.508383 °	38.582230 ° -121.509110 °	13 Y

Levee Mile Report Line	9
Start Levee Mile	2.00
End Levee Mile	2.17
Location	Land Side
Category	Earthen Levee
Item	Encroachments
The fence runs along the toe of the levee. Fall 2011	
johngw_f_20111031_443.jpg

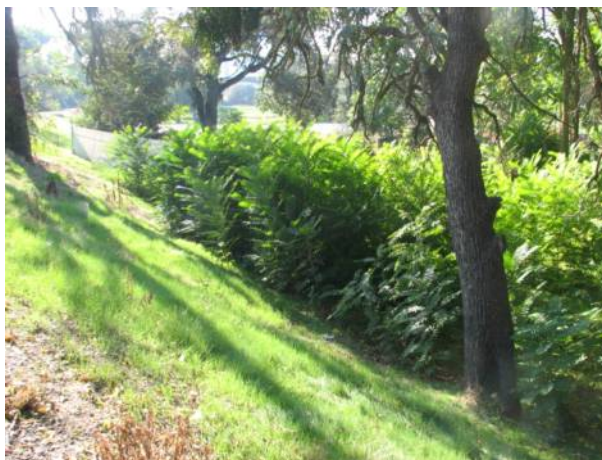
Levee Mile Report Line	10
Start Levee Mile	2.87
End Levee Mile	2.87
Location	Land Side
Category	Earthen Levee
Item	Vegetation

The vegetation on the landside toe blocks visibility. Fall 2011

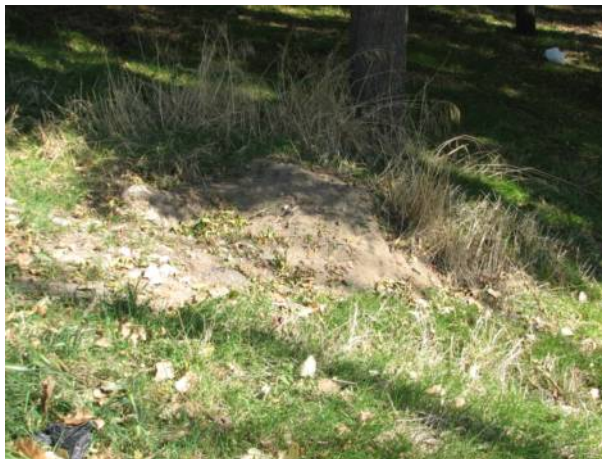
Levee Mile Report Line	11
Start Levee Mile	3.02
End Levee Mile	3.02
Location	Water Side
Category	Earthen Levee
Item	Animal Control

A large rodent hole. Fall 2011

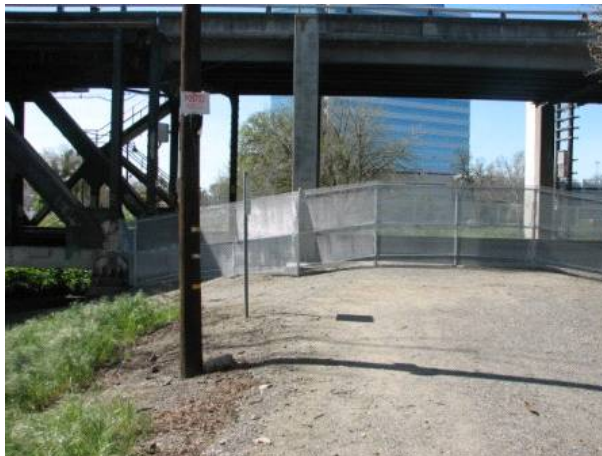
Levee Mile Report Line	12
Start Levee Mile	3.02
End Levee Mile	3.02
Location	Crown
Category	Earthen Levee
Item	Encroachments

The fence is across the levee crown on both side of the railroad tracks.

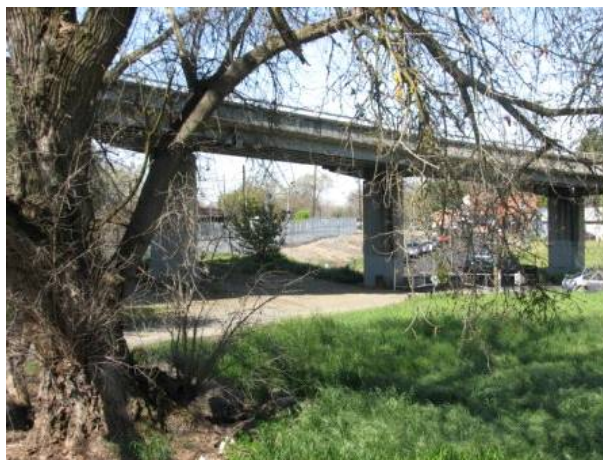
Levee Mile Report Line	12
Start Levee Mile	3.02
End Levee Mile	3.02
Location	Crown
Category	Earthen Levee
Item	Encroachments

The fence on both side of the tracks goes to Third street.

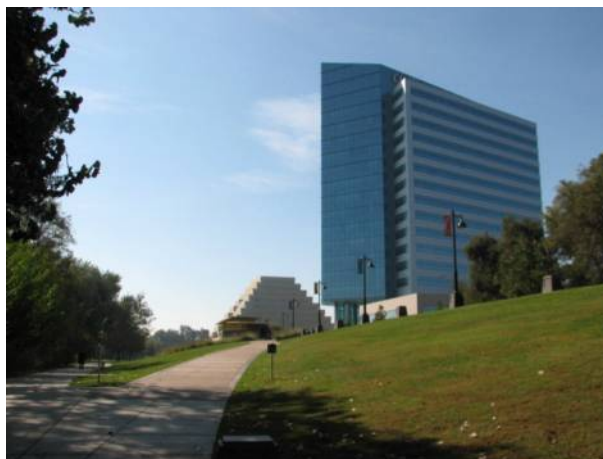
Levee Mile Report Line	13
Start Levee Mile	3.07
End Levee Mile	3.30
Location	Land Side
Category	Earthen Levee
Item	Encroachments

CalSTRS and Ziegler building. Fall 2011

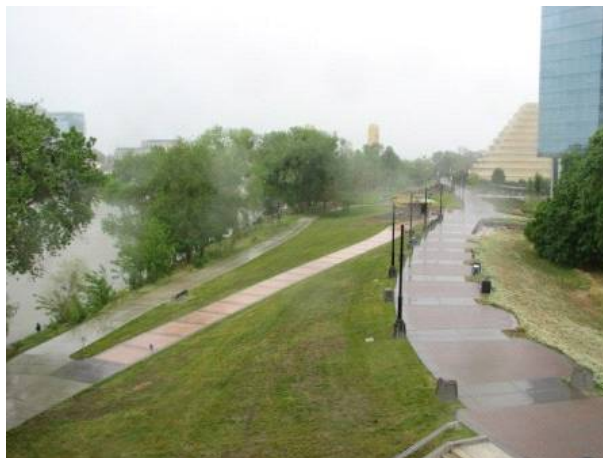
Levee Mile Report Line	14
Start Levee Mile	3.07
End Levee Mile	3.40
Location	Water Side
Category	Earthen Levee
Item	Encroachments

Landscaping on the waterside of the levee

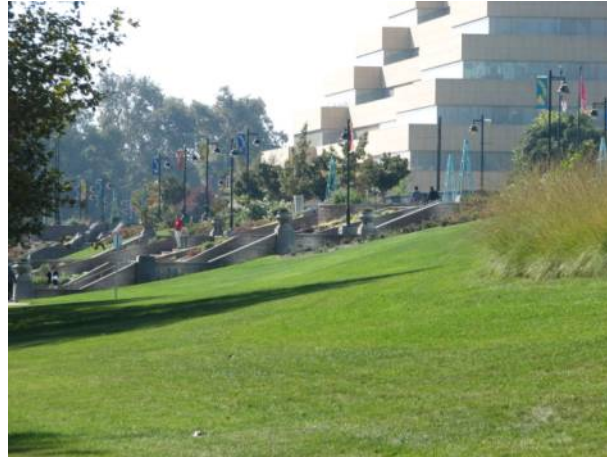
Levee Mile Report Line	14
Start Levee Mile	3.07
End Levee Mile	3.40
Location	Water Side
Category	Earthen Levee
Item	Encroachments

LMR No.	Levee Mile		Category	Item	Location *	Rating **	Action/Comment	GPS Latitude/Longitude		Issue No.
	Start	End						Start	End	
14	3.07	3.40	Earthen Levee	Encroachments	WS PO	Landscaping	38.585642 ° 38.534710 ° Inspector Comments: West Sacramento's River walk runs from Tower Bridge to I st Bridge	-121.508385 ° -121.517390 °	12	Y

Steps and landscaping on the crown and waterside of the levee. Fall 2011
